Defective Chinese Drywall Claim Form

Self-Assessment Guide for signs that a home may be affected by drywall Associated Corrosion.

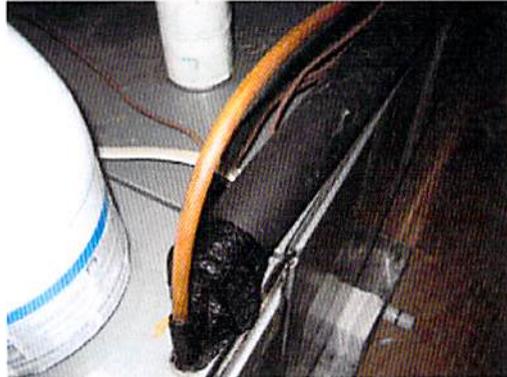
look at the un-insulated copper line going into the air handler. Compare it to the images below. The image on the left shows the normal copper color which changes with age and normal exposure to the environment. The image on the right shows the blackening copper corrosion that is typically caused by exposure to corrosive sulfide gasses.

Normal Copper Color

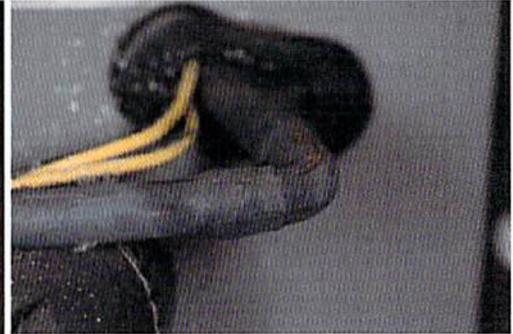
Sulfide Corroded

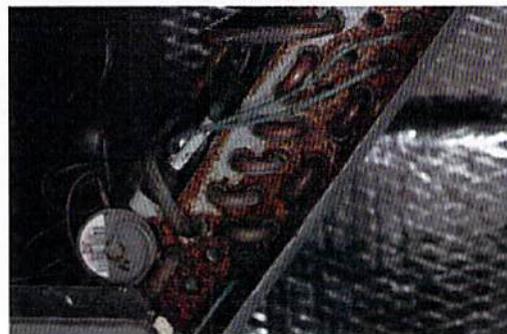
Normal

Normal copper in a rusty steel frame

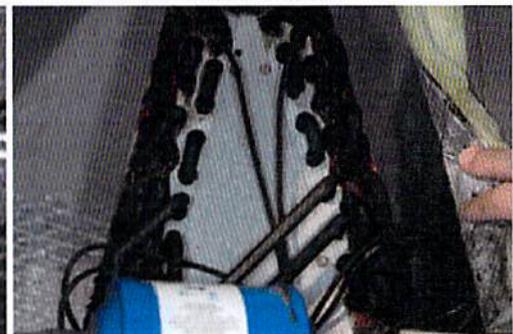
Sulfide Corroded

Sulfide corroded coil

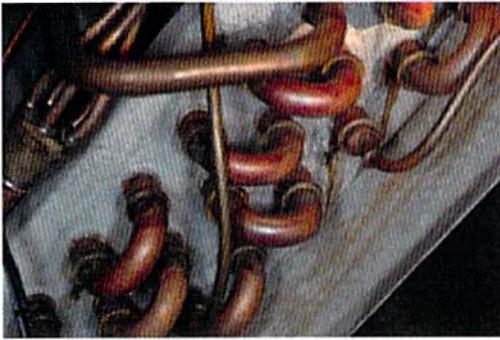
Normal copper tubing

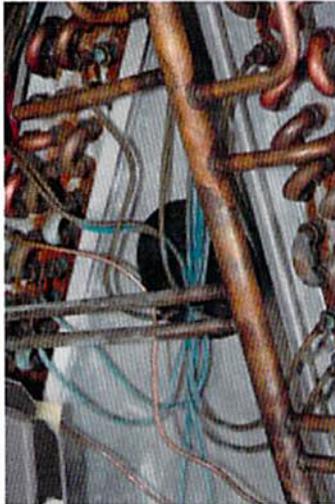
Normal copper tubing

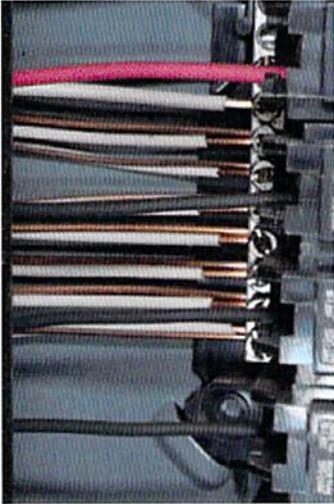
Normal wiring

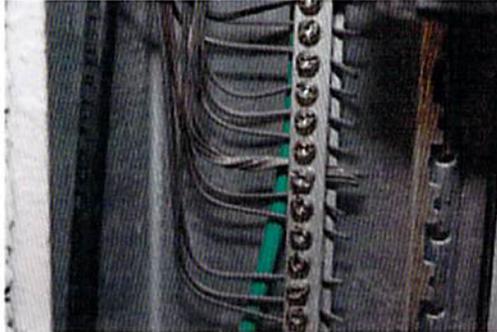
Black corrosion on wiring

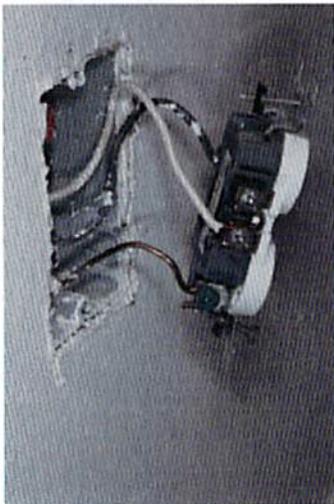
Normal outlet

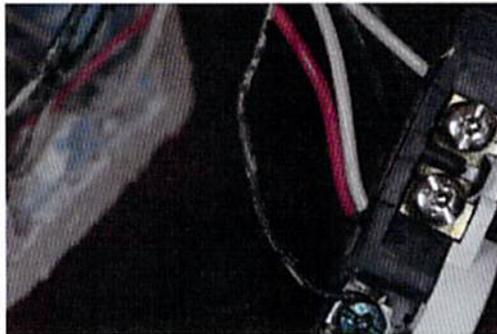
Black corrosion on wiring

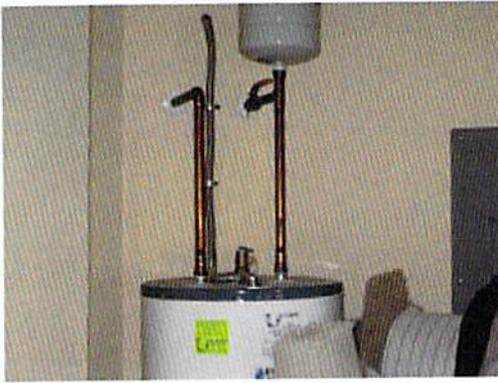
Normal copper plumbing

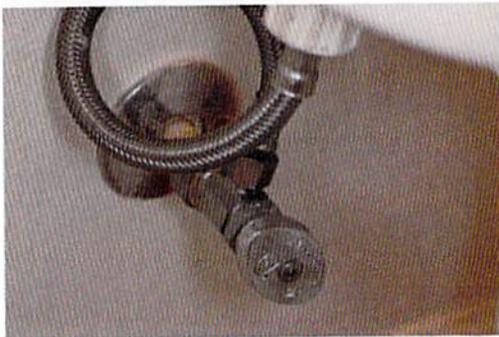
Normal shut off valve

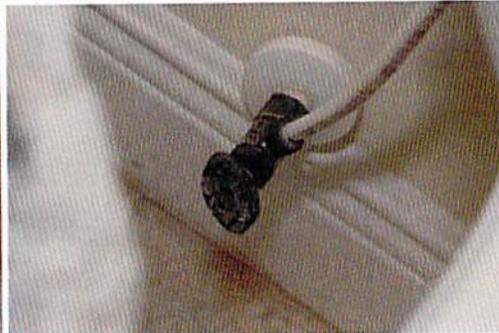
Corroded shut off valve
